# Tree Management Experts

## City of San Bruno

**Project: Florida Park**  
**Existing tree evaluations**

## ARBORIST REPORT

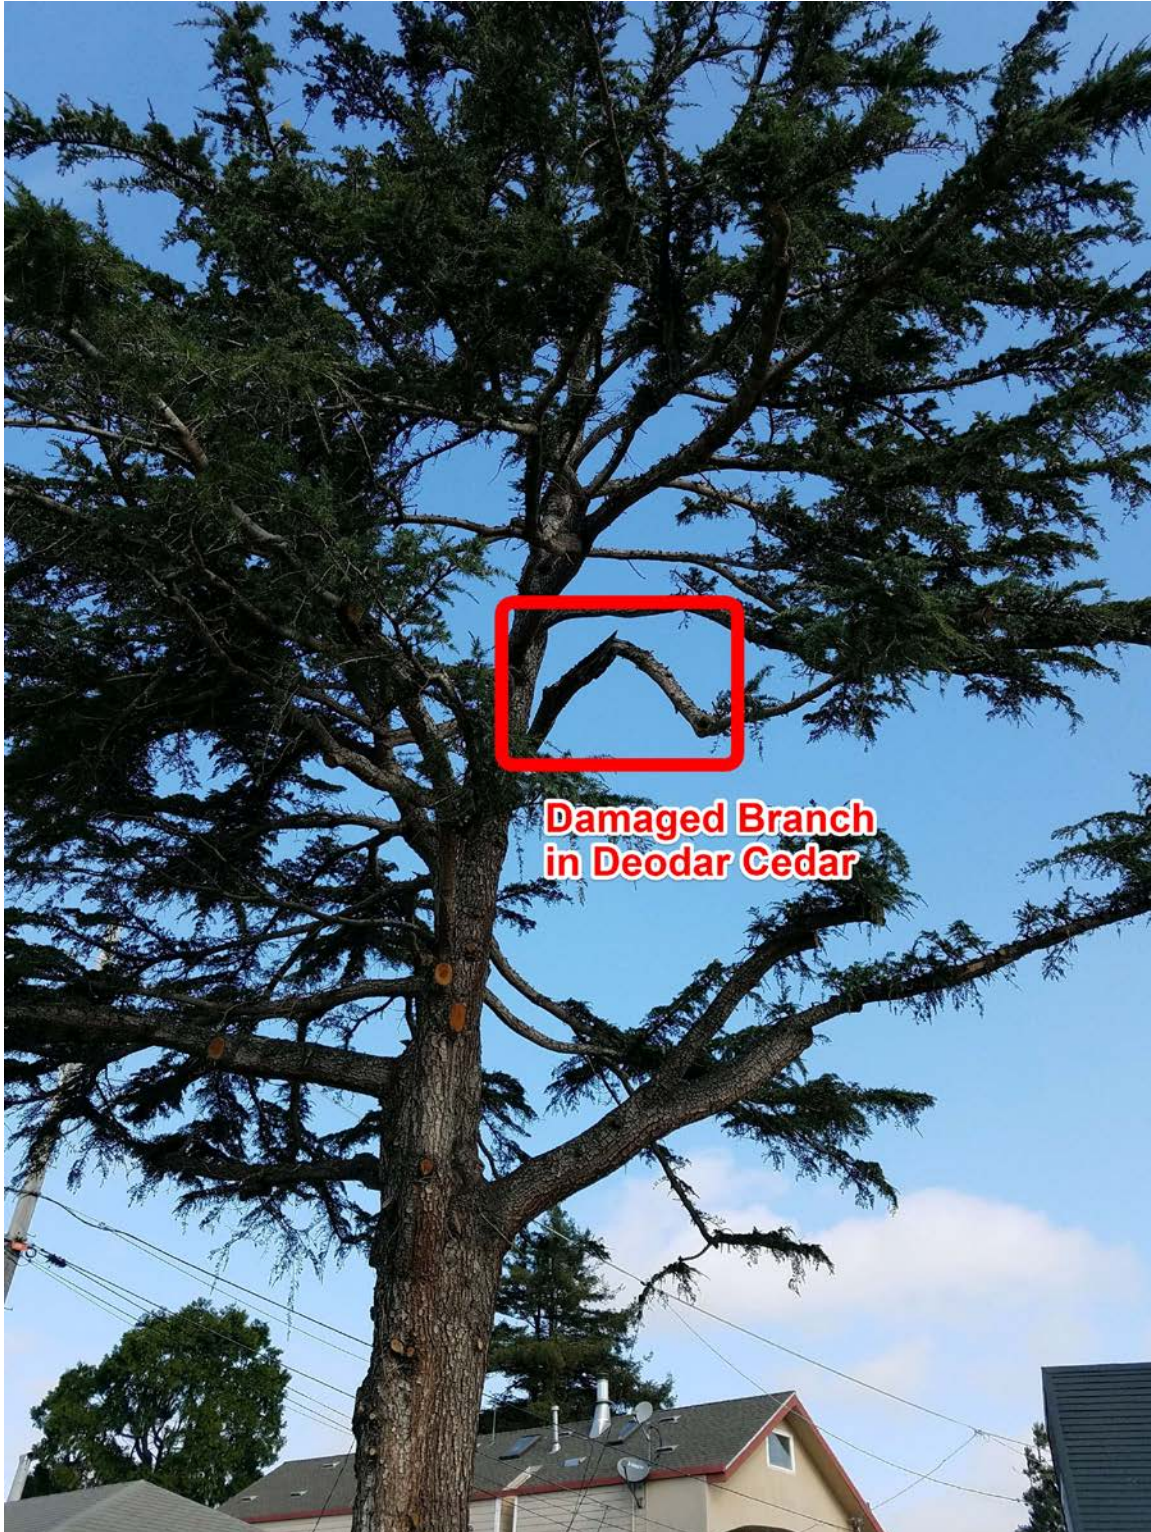
The tree was recently pruned and some lower limbs were removed. There are no dead branches or particularly end-heavy branches in the tree. One larger limb on the south side has a decayed and cracked area and should be removed. The tree has no other pruning needs at this time.

**Damaged Branch  
in Deodar Cedar**

We recommend that the Deodar cedar be pruned to remove the decayed limb and that a Tree Protection Report be created and implemented.

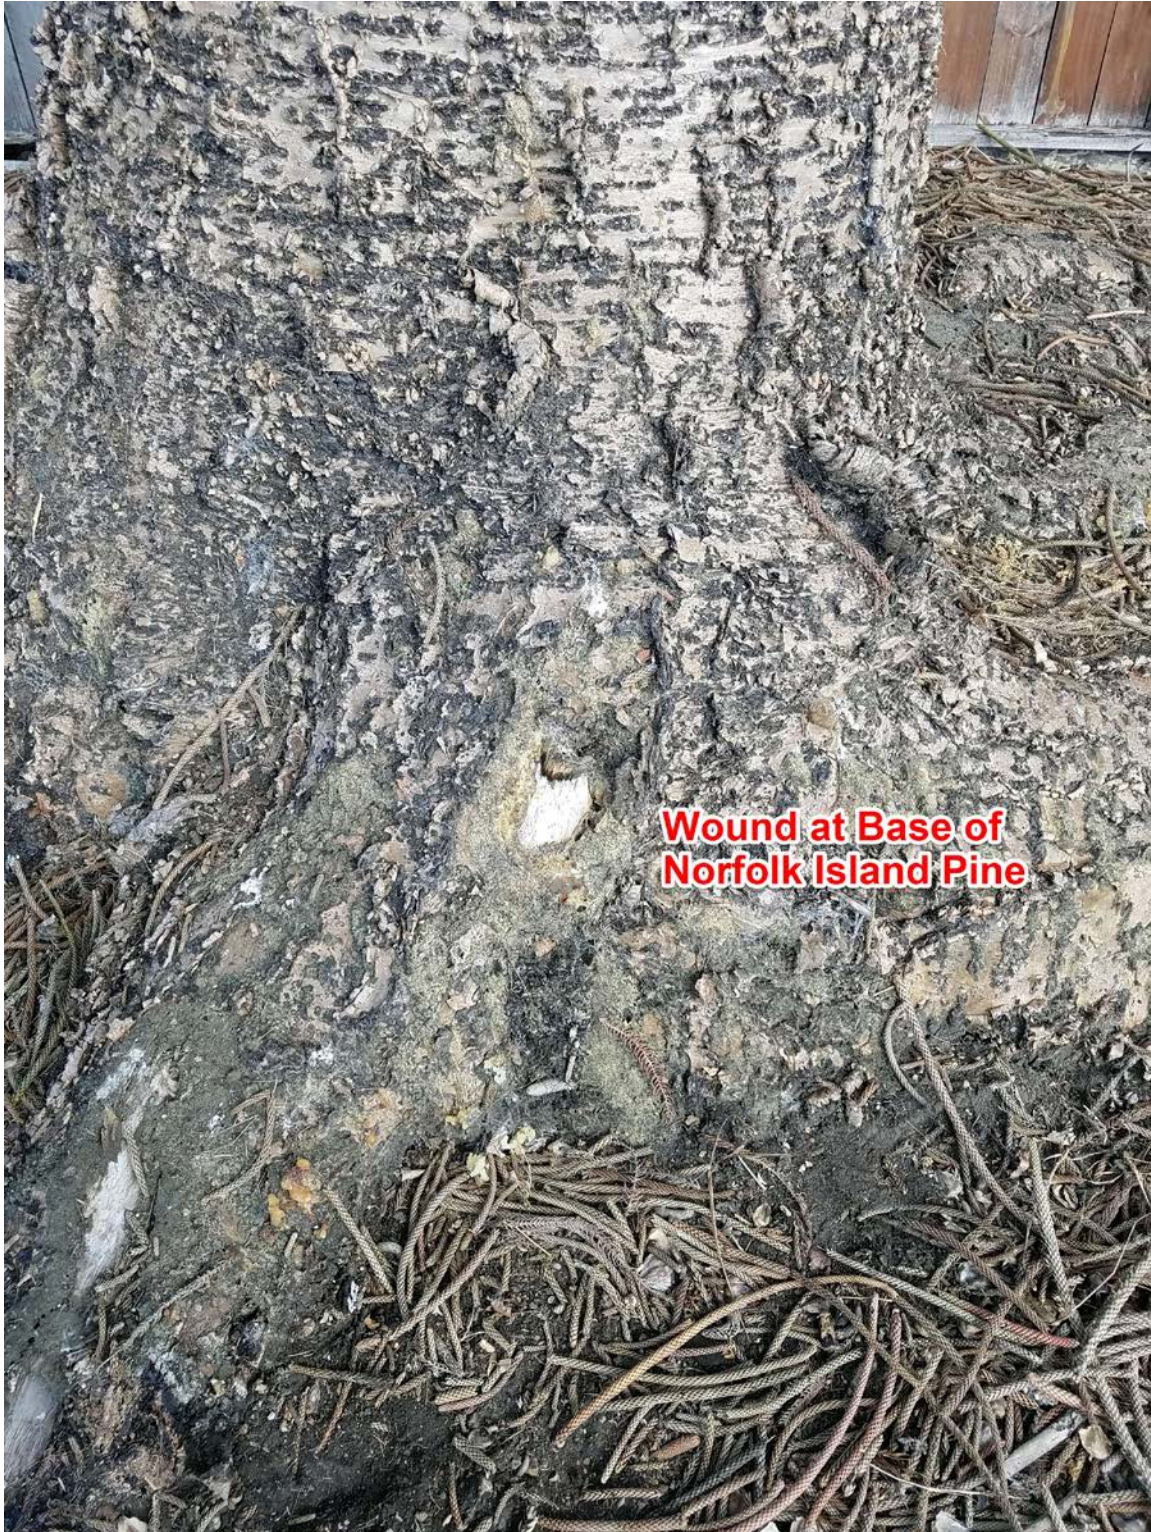
The Norfolk Island pine is at the north end of the property and near the neighboring home. The trunk is about 36.5 inches diameter, is straight and without any visible defects in the lower regions except for 2 bark wounds at the base. The tree is about 90 feet tall, and has had the top removed after it had died. Lower limbs have been removed, and with normal limbs and normal limb distribution in the upper 60 percent of the tree (60% live crown ratio or LCR). There was a heavy load of debris beneath the tree comprised of fallen branchlets and cones including some squirrel damaged foliage.

**Wound at Base of  
Norfolk Island Pine**

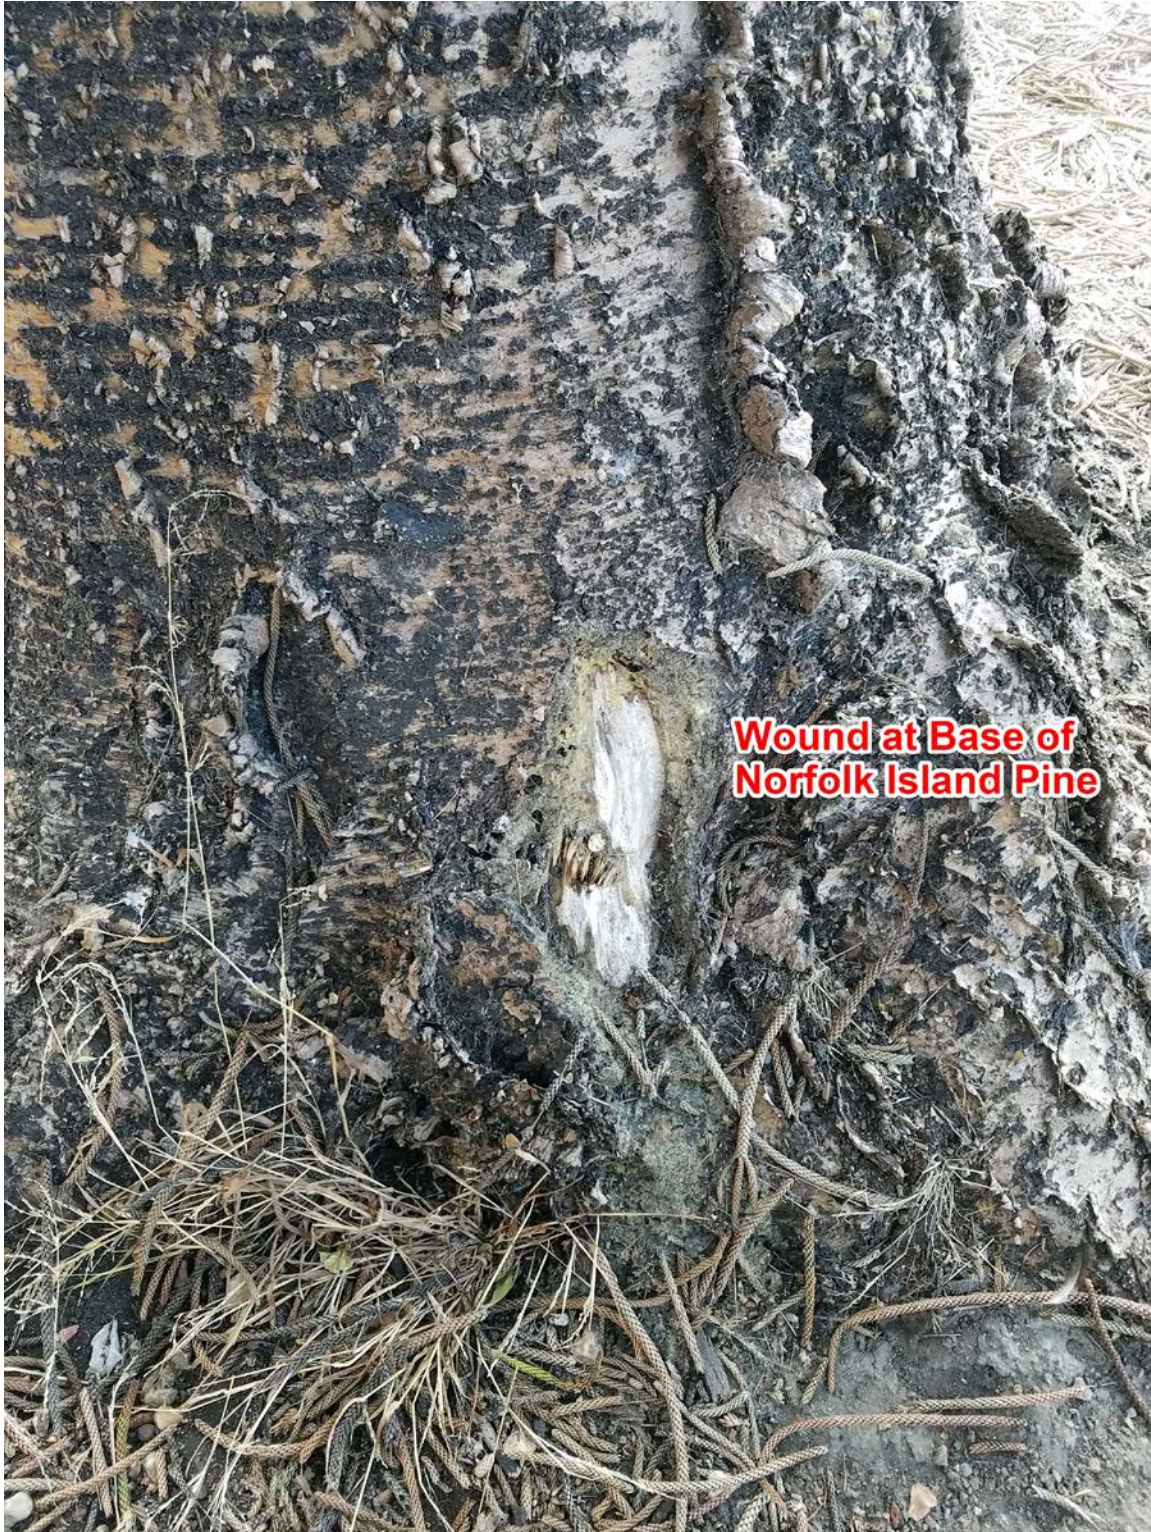
**Wound at Base of  
Norfolk Island Pine**

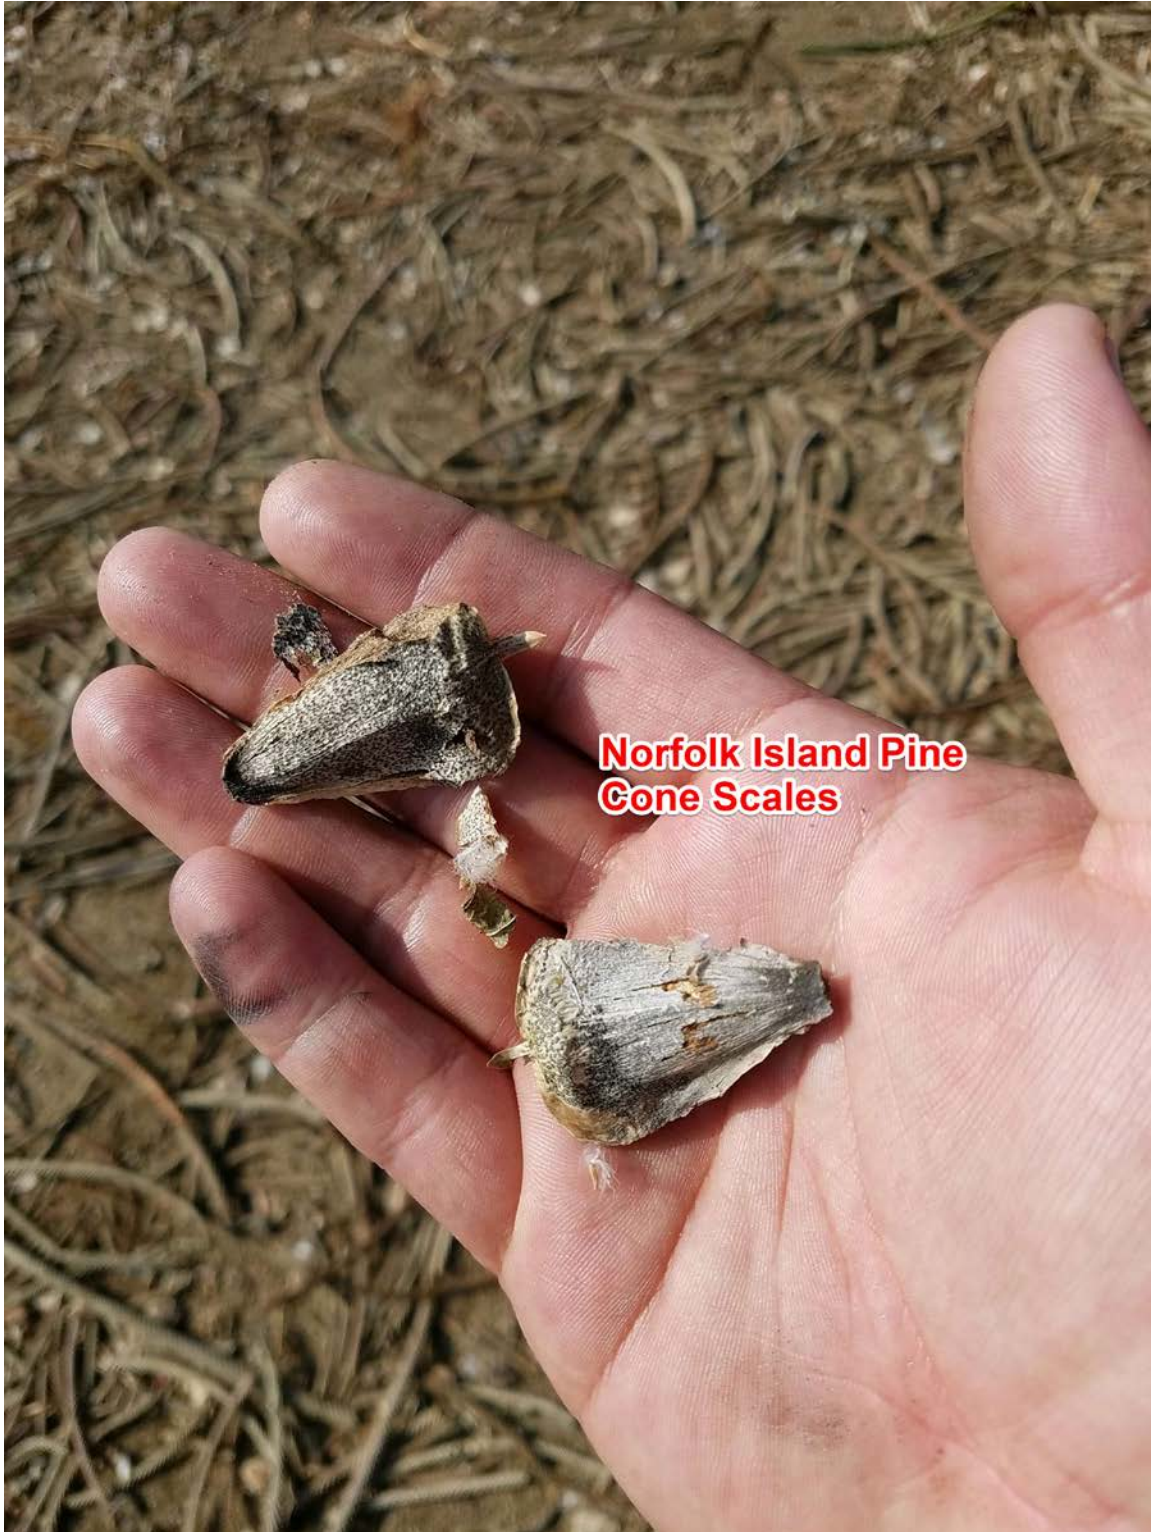
This tree is at a maturity point where it is producing many cones, and there are likely more than 100 currently in the tree. These cones are about the size of a grapefruit and weigh about 1 to 2 pounds. As with all *Araucaria* species, most cones mature, dry out and then disintegrate and fall as cone scales. There are frequent exceptions to the disintegration, however, and green cones can fall. The presence of squirrel damage increases the risk that a green cone could be chewed free. These cones fall from near the top of the tree, or at about 50 to 80 feet. If a green cone were to hit someone it would cause serious harm or death.

**Norfolk Island Pine  
Cone Scales**

We recommend that the Norfolk Island pine be considered for removal due to the risks posed from the cones.

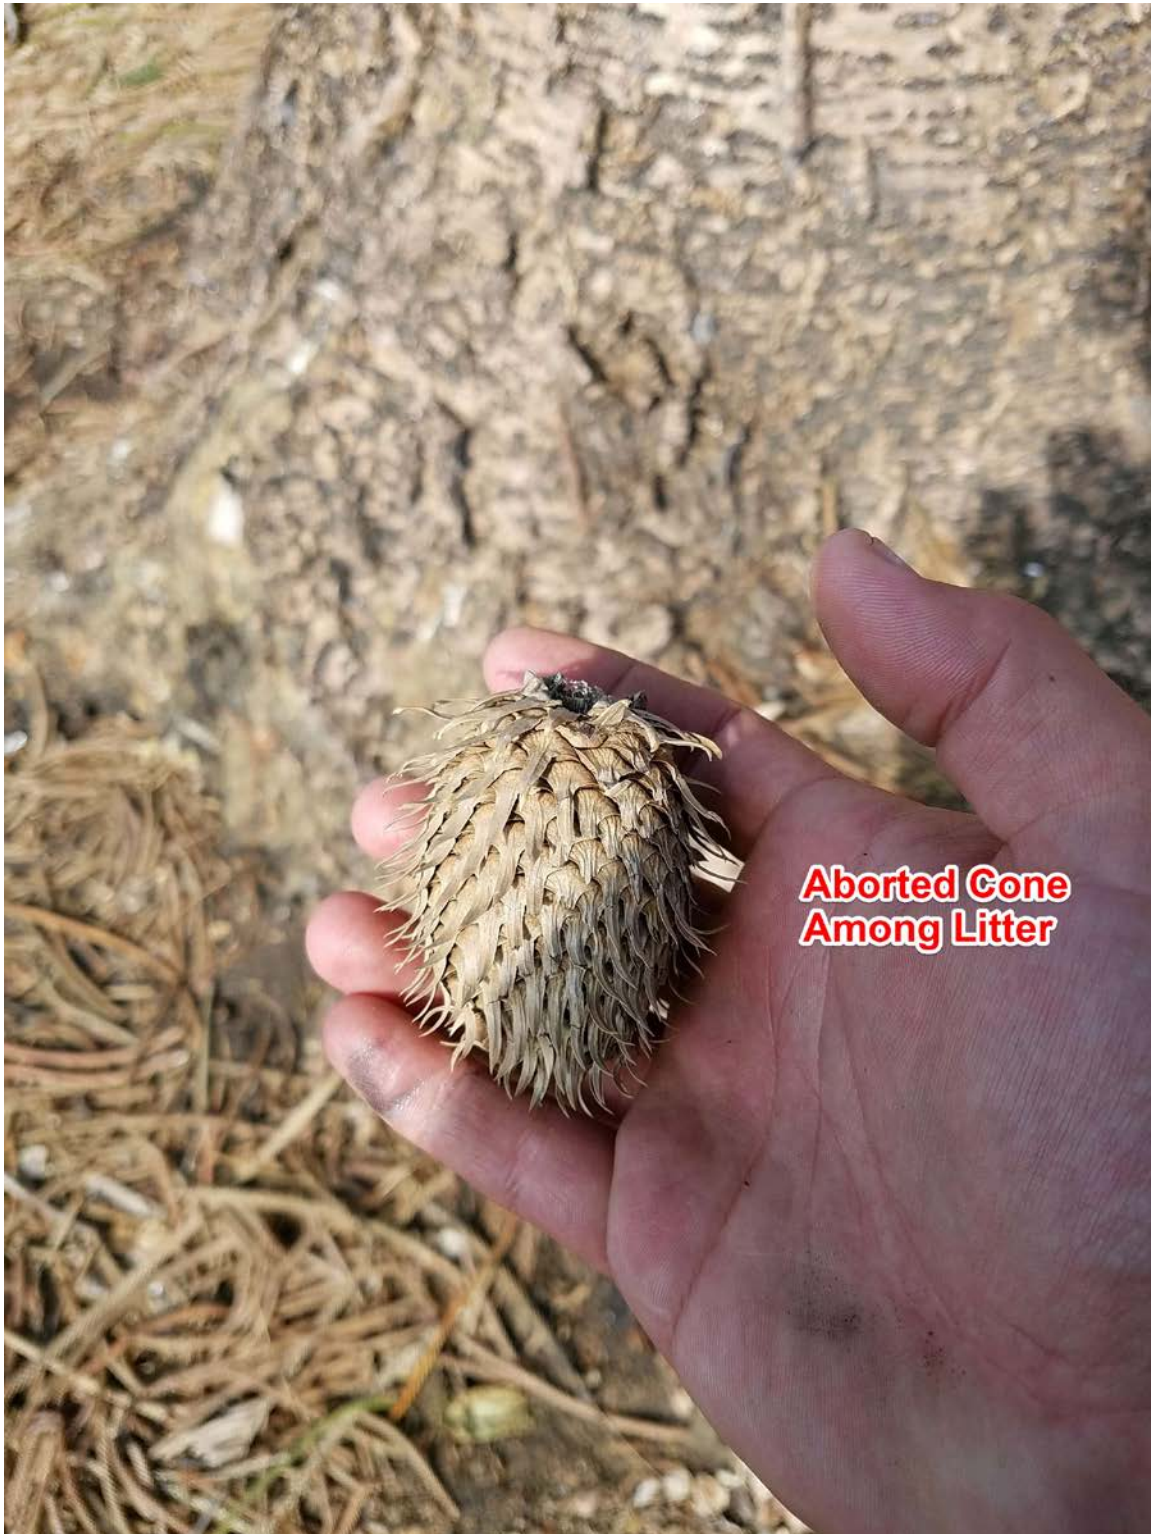
**Aborted Cone  
Among Litter**
