# Arborist Report

**Mills Park  
San Bruno CA**

*Prepared for:*  
**Signature Development Group  
2201 Broadway Suite 604  
Oakland, CA 94612**

*Prepared by:*  
**HortScience, Inc.  
325 Ray Street  
Pleasanton, CA 94566**

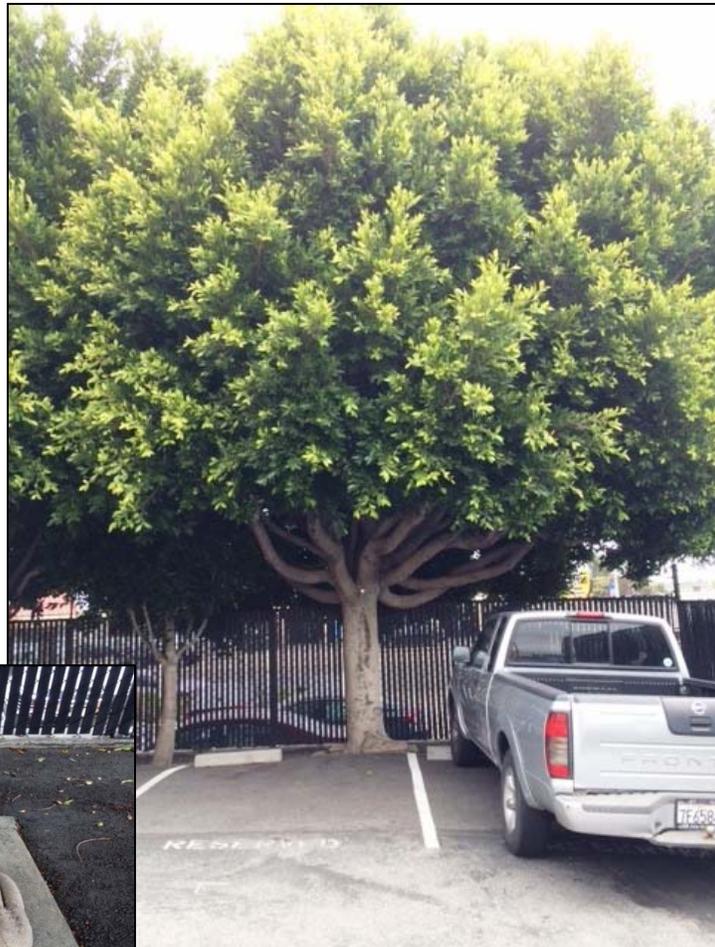
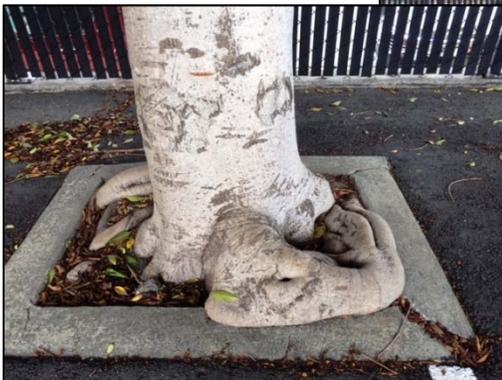
Six (6) Indian laurel figs were growing in a row in the parking lot in the southern block between White Wy. and El Camino Real. They were young to semi-mature and planted in very small cut-outs (Photo 1). The trees had filled the available space but had full, dense canopies. Half were in good condition and half were in fair.

**Photo 1:** Looking east at Indian laurel fig #64 and 65 (L to R). The trees were growing in small cut-outs in a parking lot.

Inset shows the base of Indian laurel #65, which had grown over and broken the adjacent concrete.

<b>Tree No.</b>	<b>Common Name</b>		<b>Trunk Diameter</b>	<b>Recommendation</b>
61	Indian laurel fig	14	Yes	Remove, within building B
62	Indian laurel fig	14	Yes	Remove, within building B
63	Indian laurel fig	12	Yes	Remove, within building B
64	Indian laurel fig	7	No	Remove, within building B
65	Indian laurel fig	17	Yes	Remove, within building B
