**California Department of Resources
Recycling and Recovery – CalRecycle**

**Pre- and Post-Removal
Activity Results for the
Glenview Incident**

1680 Claremont Drive
San Bruno, California

Pre- and Post-Removal Photographs

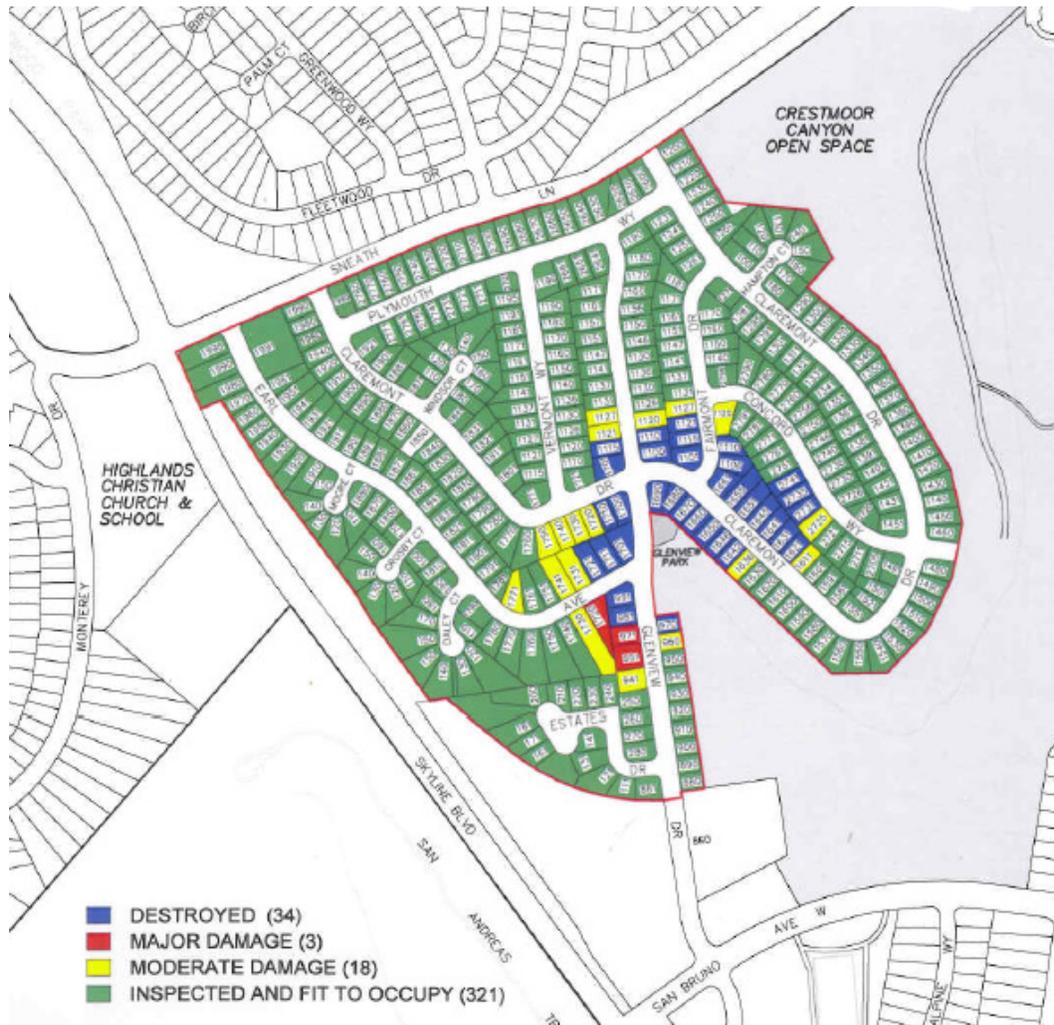
Figure 3. Impacted Homes at the Glenview Fire Incident. (Source: CalRecycle 2010)

Thirty-five homes and other structures were destroyed during the Glenview Fire. One playground was also destroyed.

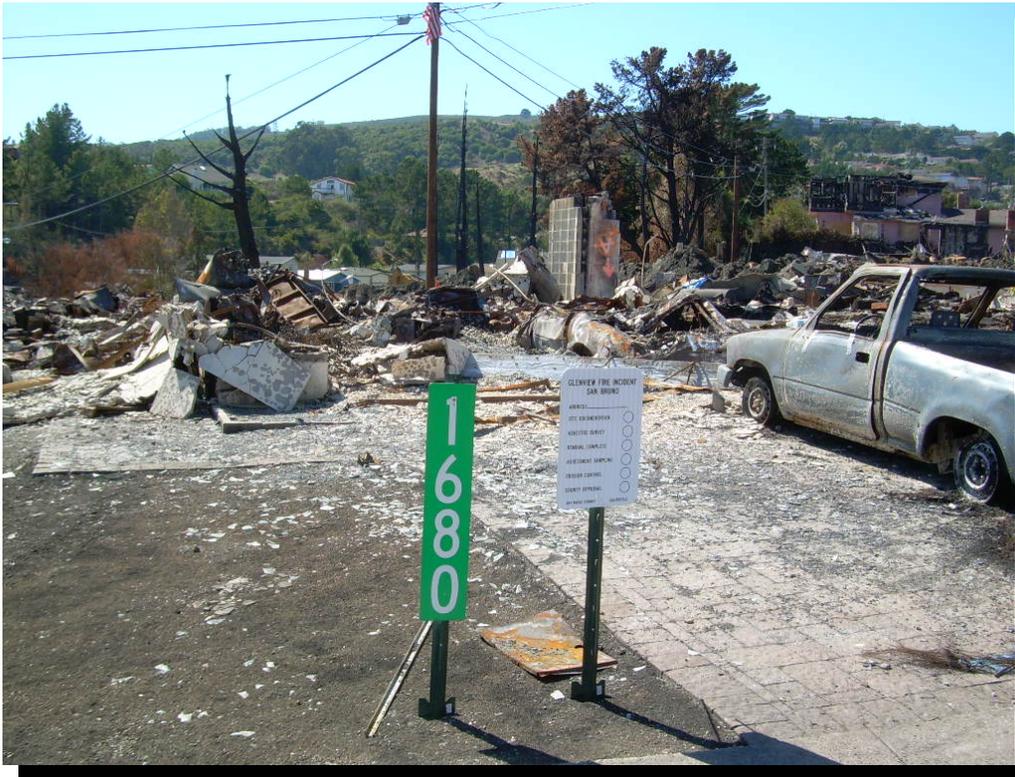
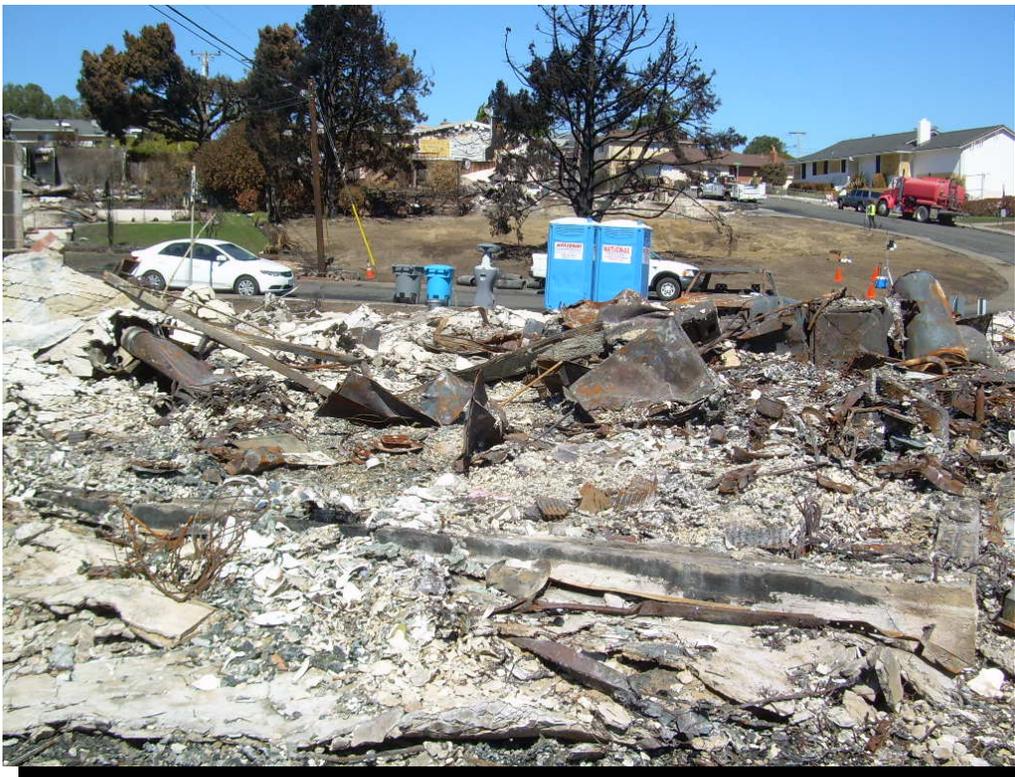
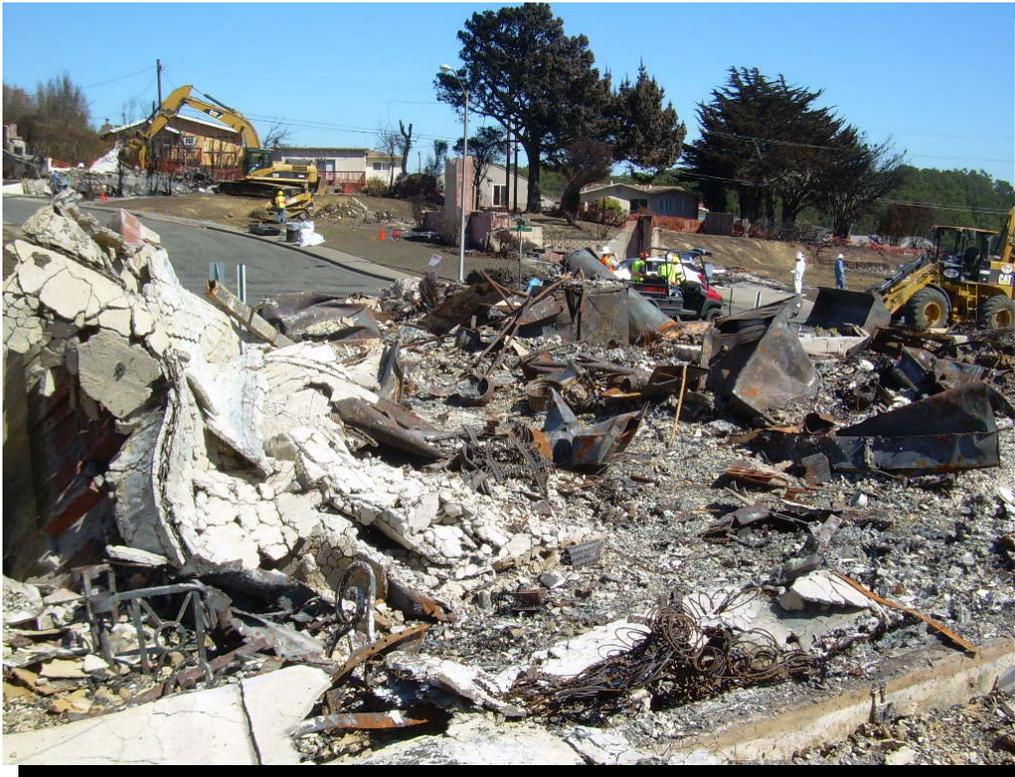
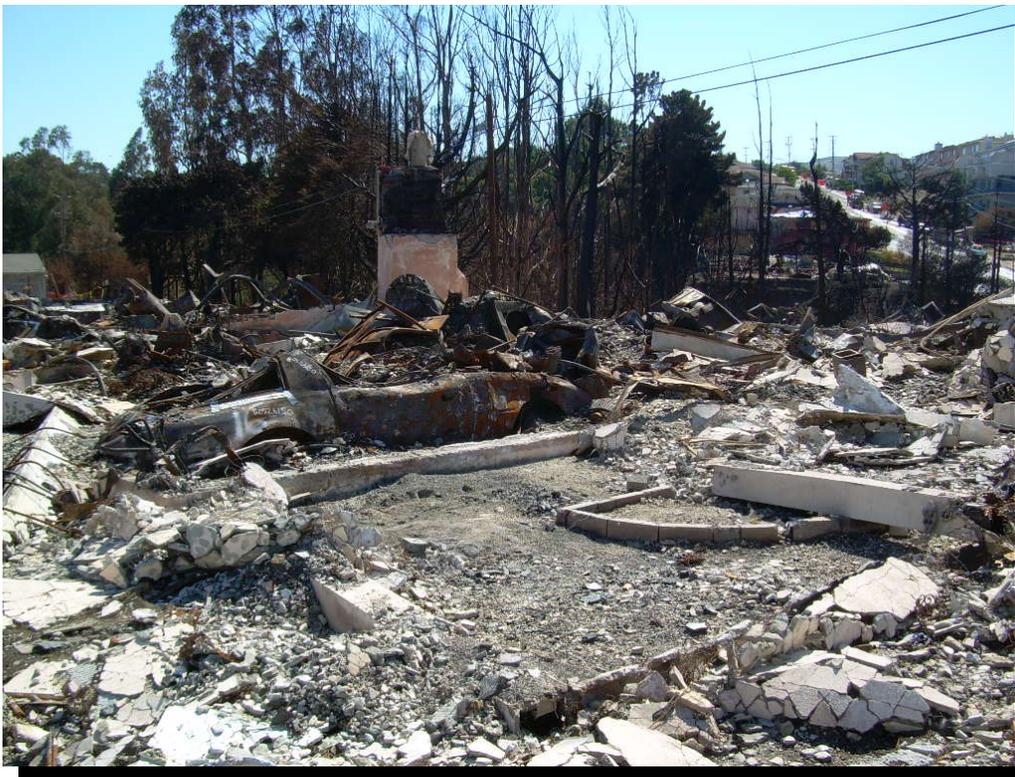
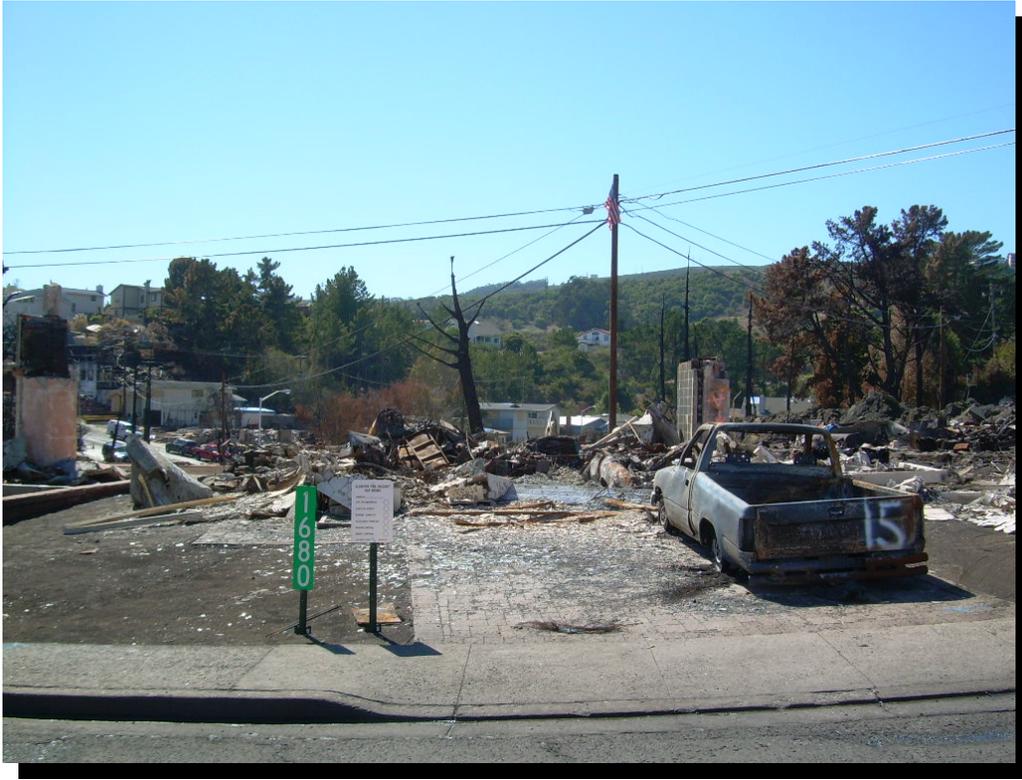
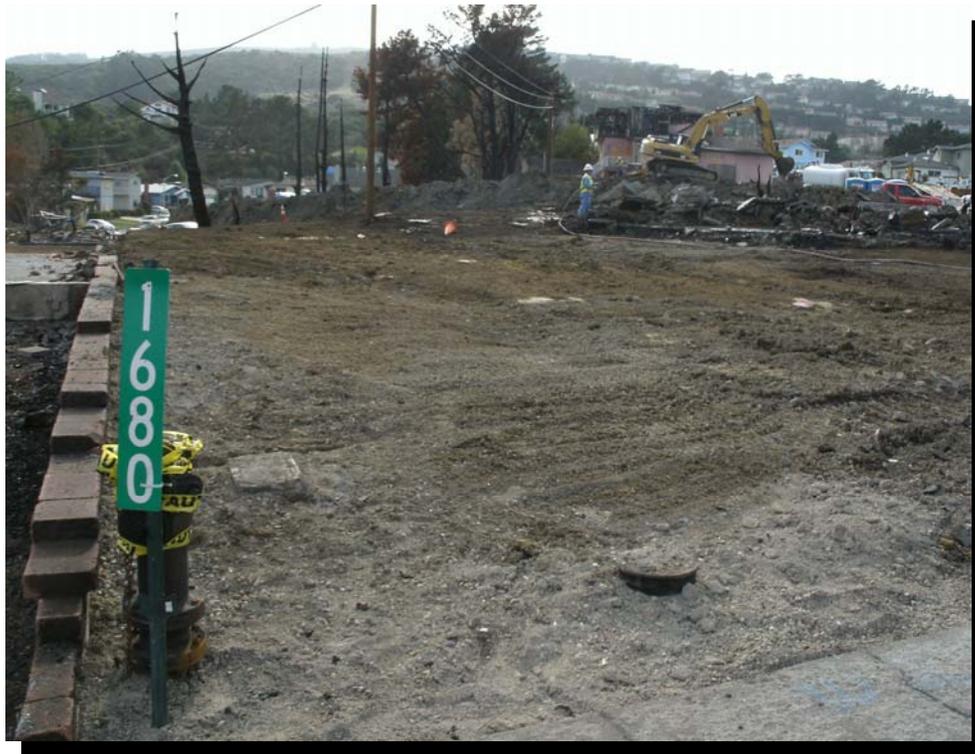
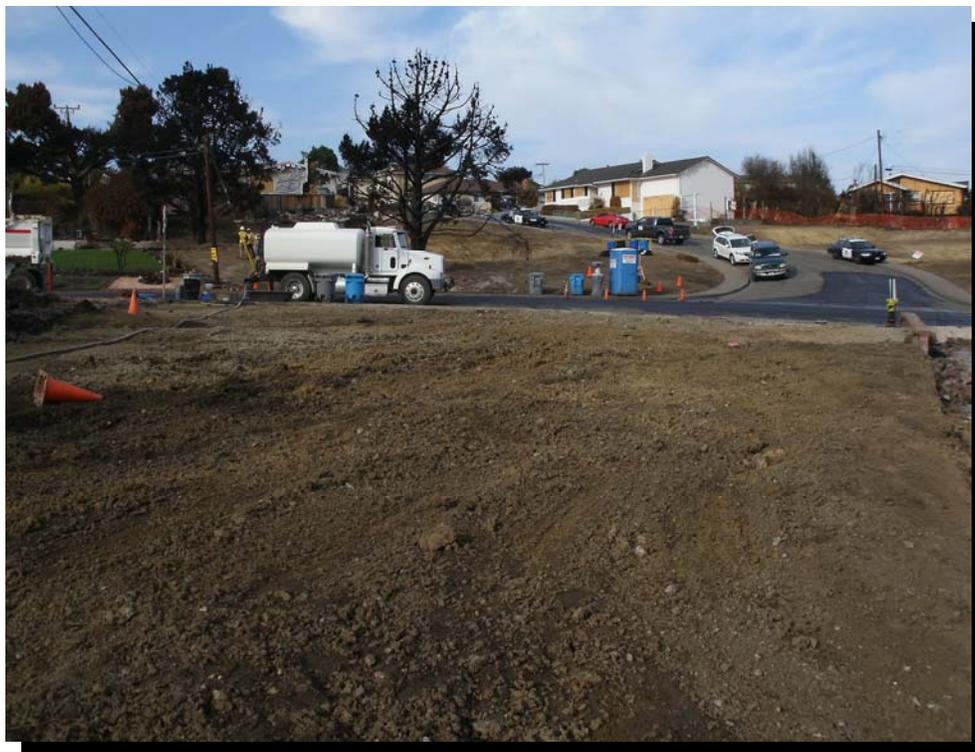
Pre-removal photographs were taken of the Site and are included in Appendix A. Approximate dimensions of the structure and ash/debris footprint and notes of visual

A comparison of the analytical results to the established cleanup goals showed that results were well below the cleanup goals. Based on these results, and in consultation with CalRecycle and San Mateo County, the removal effort was considered complete. ARCADIS photographed the Site after cleanup and the post-removal photographs are included in Appendix A.

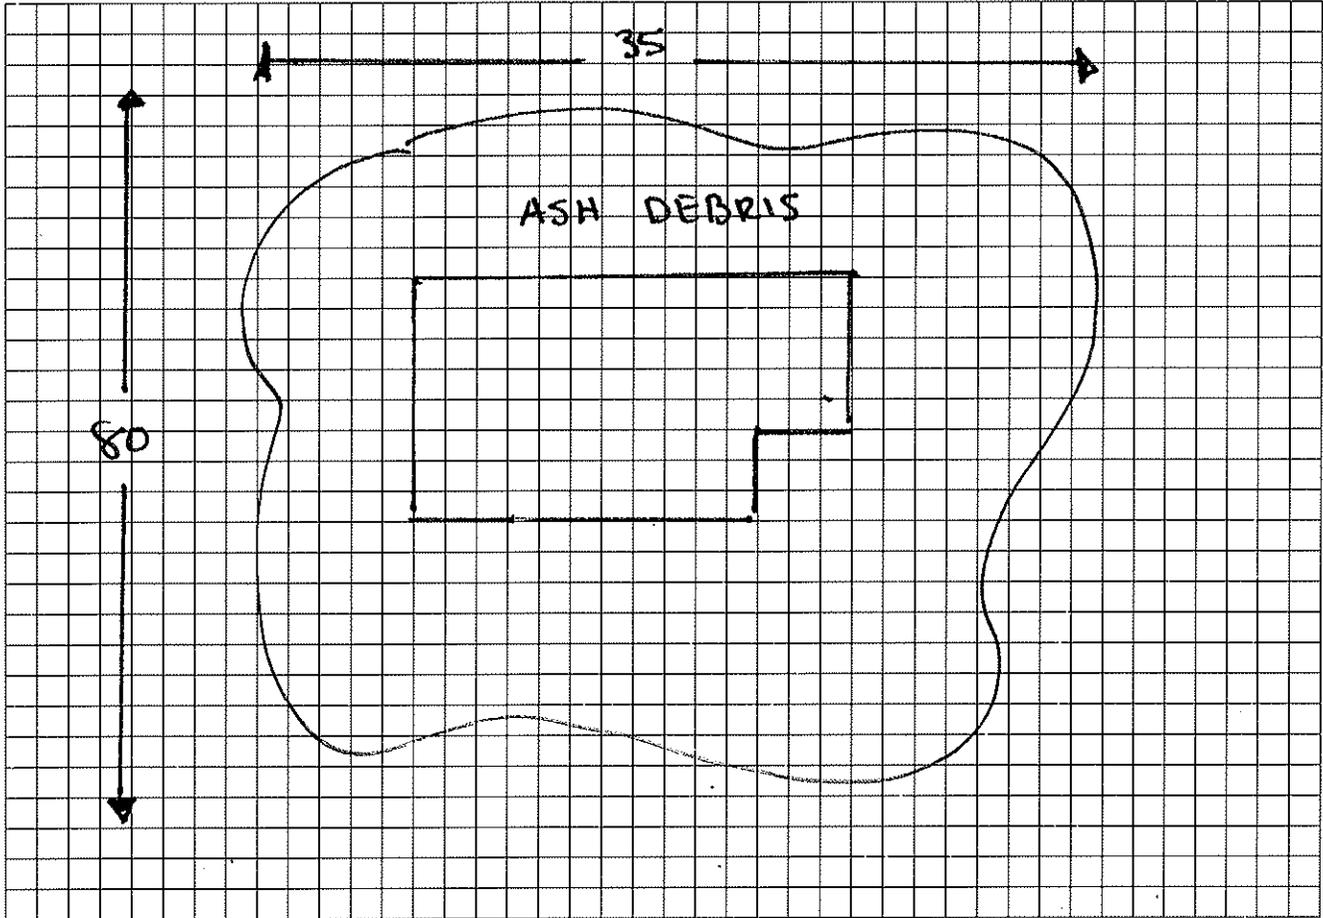
Ash/Debris Footprint with Dimensions

NOTES/OBSERVATIONS

Vehicle	<u>1</u>	Storage Shed	<u> </u>	Concrete Slab	Yes <input type="radio"/> No <input checked="" type="radio"/>
Motorcycle	 	Pool/Spa	Yes <input type="radio"/> No <input checked="" type="radio"/>	Stem Walls	<input checked="" type="radio"/> Yes <input type="radio"/> No
ATV	<u> </u>	Gazebo	Yes <input type="radio"/> No <input checked="" type="radio"/>	Driveway	<input checked="" type="radio"/> Yes <input type="radio"/> No
Boat	<u> </u>	Chimney	<input checked="" type="radio"/> Yes <input type="radio"/> No	Asphalt	<u> </u>
Trailer	<u> </u>	Retaining Wall	Yes <input type="radio"/> No <input checked="" type="radio"/>	Concrete	<input checked="" type="checkbox"/>
Motorhome	<u> </u>	Fencing	Yes <input type="radio"/> No <input checked="" type="radio"/>	Brick	<u> </u>
				Gravel	<u> </u>
