# Tree Management Experts

## City of San Bruno

**Project: Florida Park**  
**Existing tree evaluations**

## ARBORIST REPORT

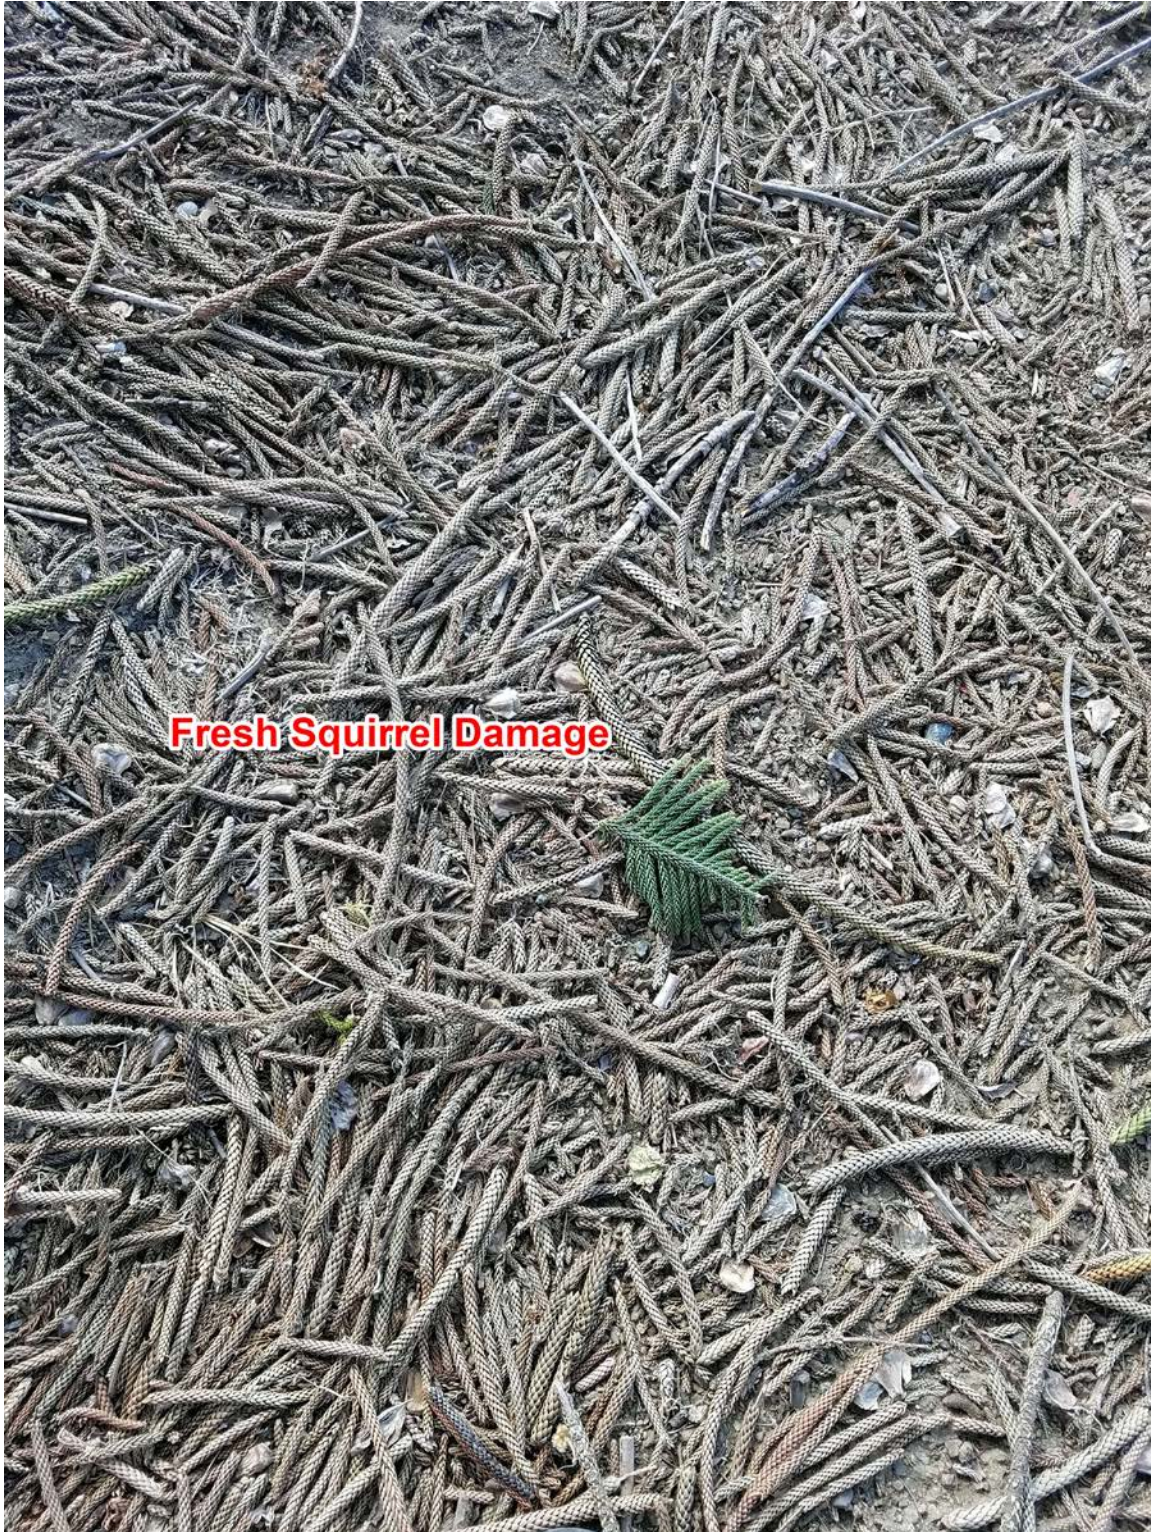
**Damaged Branch  
in Deodar Cedar**

The tree was recently pruned and some lower limbs were removed. There are no dead branches or particularly end-heavy branches in the tree. One larger limb on the south side has a decayed and cracked area and should be removed. The tree has no other pruning needs at this time.

We recommend that the Deodar cedar be pruned to remove the decayed limb and that a Tree Protection Report be created and implemented.
